Roanoke, Town of
(White Hotel)(Cillooly Hotel)
Roanoke
Lewis County
West Virginia

HABS No. WV-209-F

WRITTEN HISTORICAL AND DESCRIPTIVE DATA

ROANOKE, TOWN OF
(White Hotel)(Gillooly Hotel)

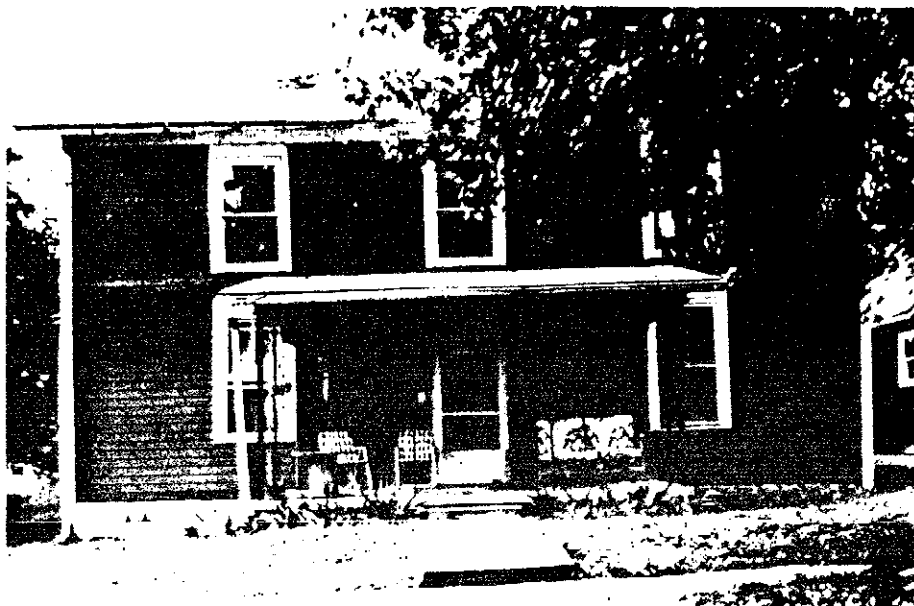
Perspective control photograph of the southeast elevation of the
White Hotel in 1981.

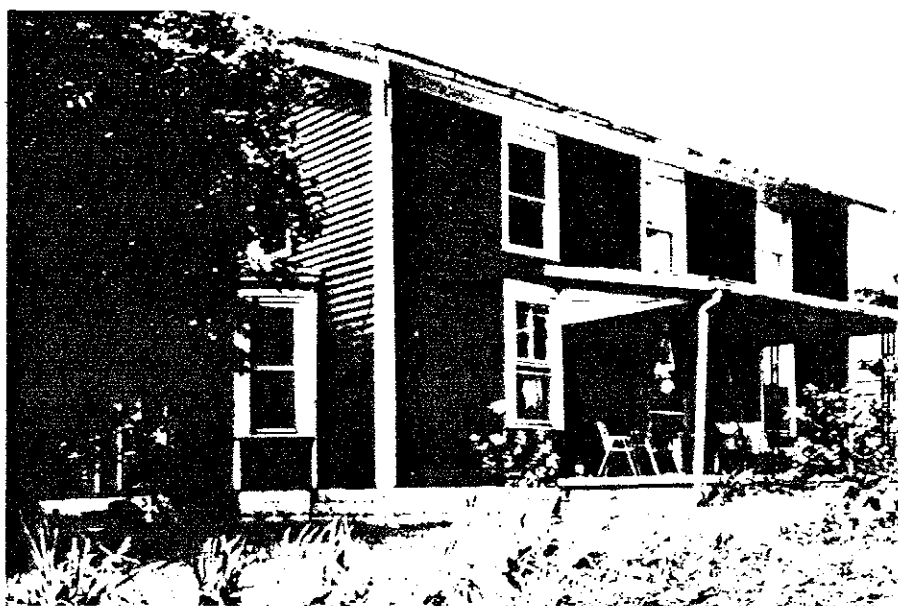
Perspective control photograph of the southeast and southwest elevations of
White Hotel in 1981.

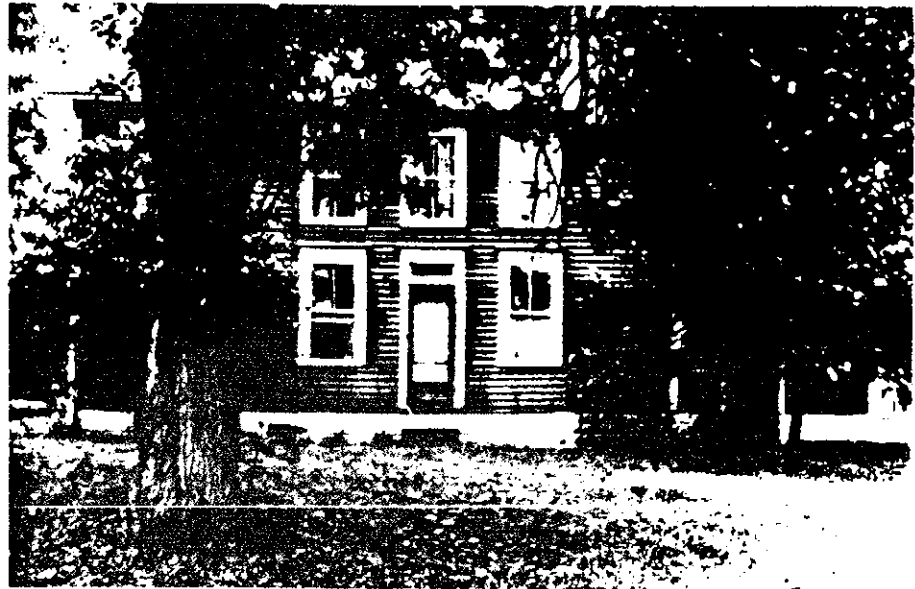
White Hotel
elevation.

Perspective control photograph of the southwest elevation of the
in 1981. Note the exterior door in this

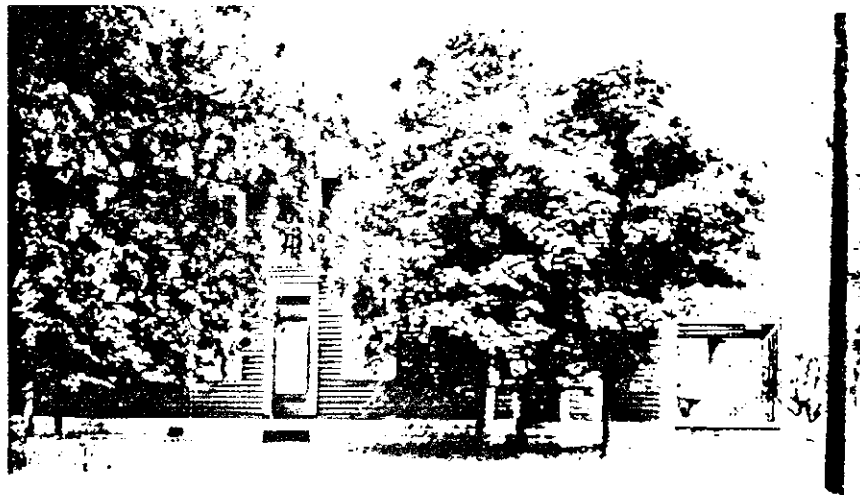
The southwest elevation of the White Hotel in
1981. In this photograph, the porch attached to the southeast elevation is visible at
right.

Porches: A 7'11" wide x 16'3" long porch is centered on the southeast wall. The 3 1/2" thick concrete deck is raised 11" above grade and is supported by a concrete block foundation. Two courses of concrete block are visible above grade. An asphalt-shingled shed roof supported by four wrought-iron columns covers the porch; the porch deck is accessed by a single step (39 1/2" wide x 13" deep x 4 1/2" rise) plus a 5 1/4" riser. A concrete sidewalk leads to the step.

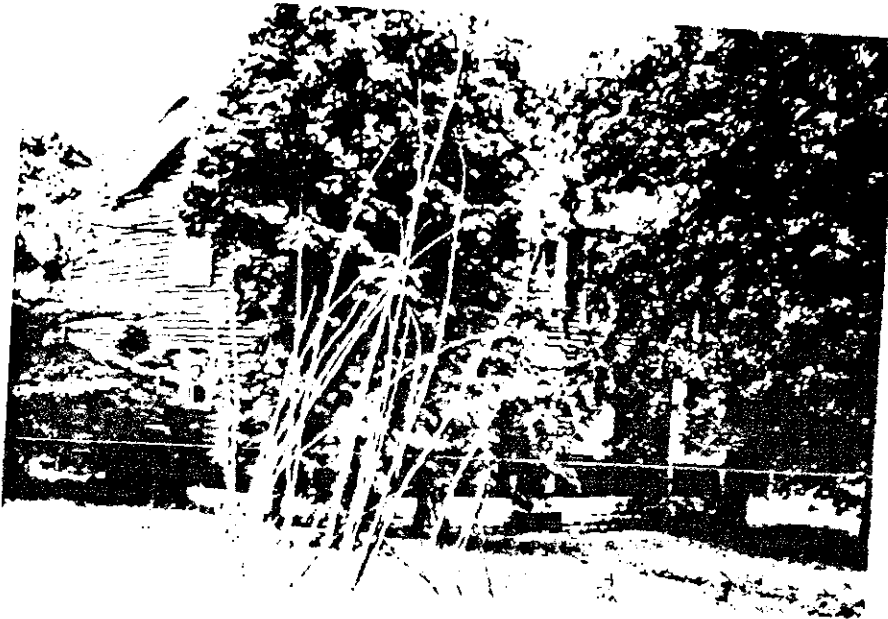
Perspective control photograph of the southwest and northwest elevations of
White Hotel in 1981.

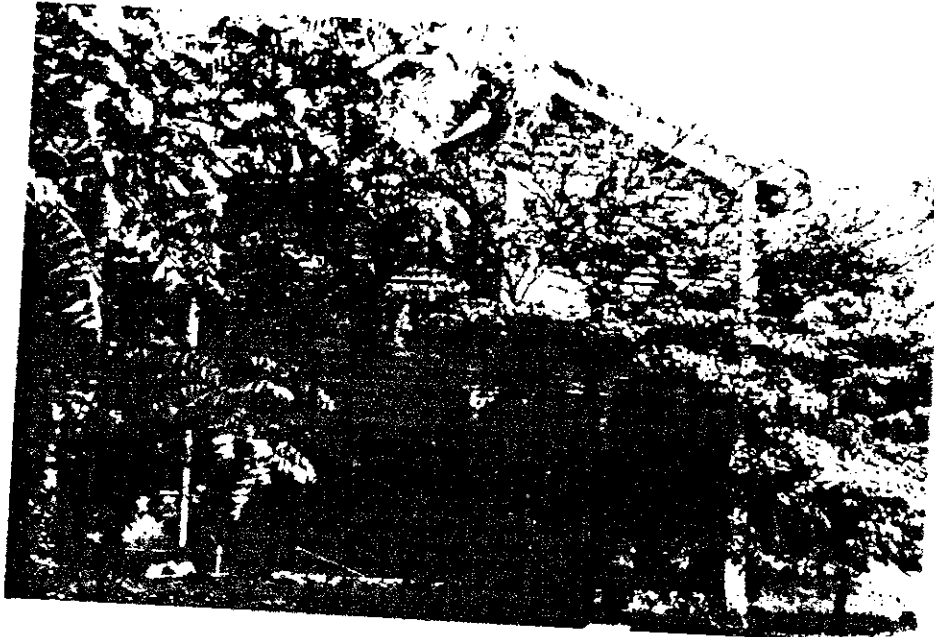
Perspective control photograph of the northwest elevation of the
White Hotel in 1981.

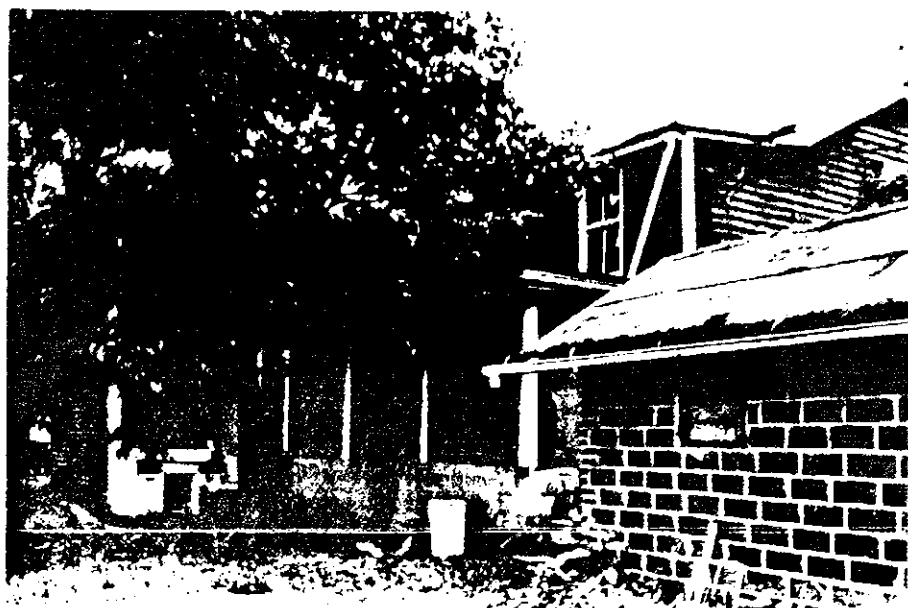
Perspective control photograph of the northwest and northeast elevations of the White Hotel in 1981. Note the porch attached to the northeast elevation.

A second porch (7'4" wide x 27'6" long) is attached to the structure on the northeast side of Rooms 5, 6 and 7; the deck is a concrete slab on grade; the porch is enclosed by a 3' high wall of 3 1/2" concrete blocks on top of which are five unevenly-spaced pillars (perhaps used as framing for the attachment of window screening as well as roof supports); the porch is covered by a flat roof of tarred decking overlaid with asphalt shingles; there is a screen door along the northeast side of the porch and another at the north corner of the porch.

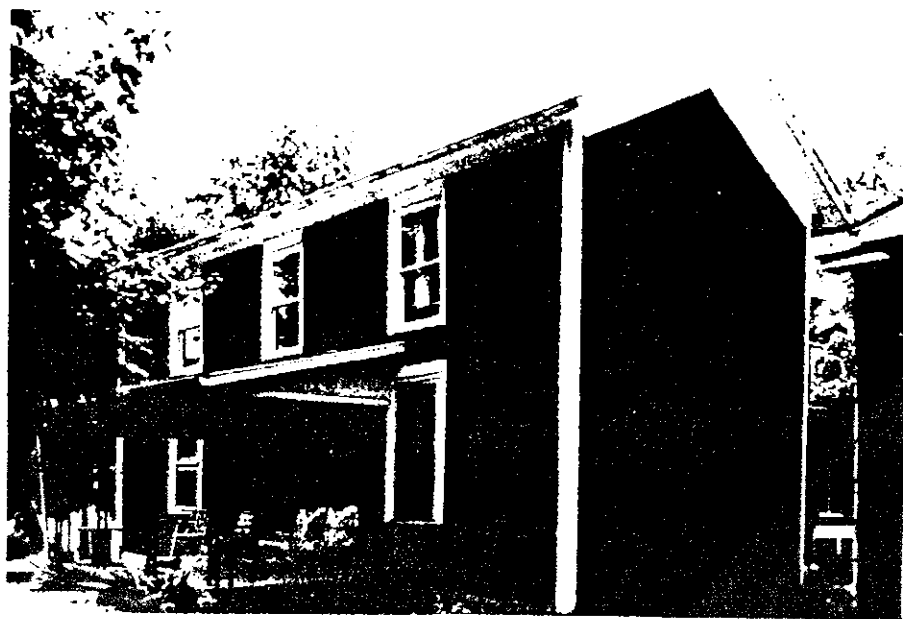
Perspective control photograph of the northeast and southeast elevations of the White Hotel in 1981. Note the porch attached to the southeast elevation at left.

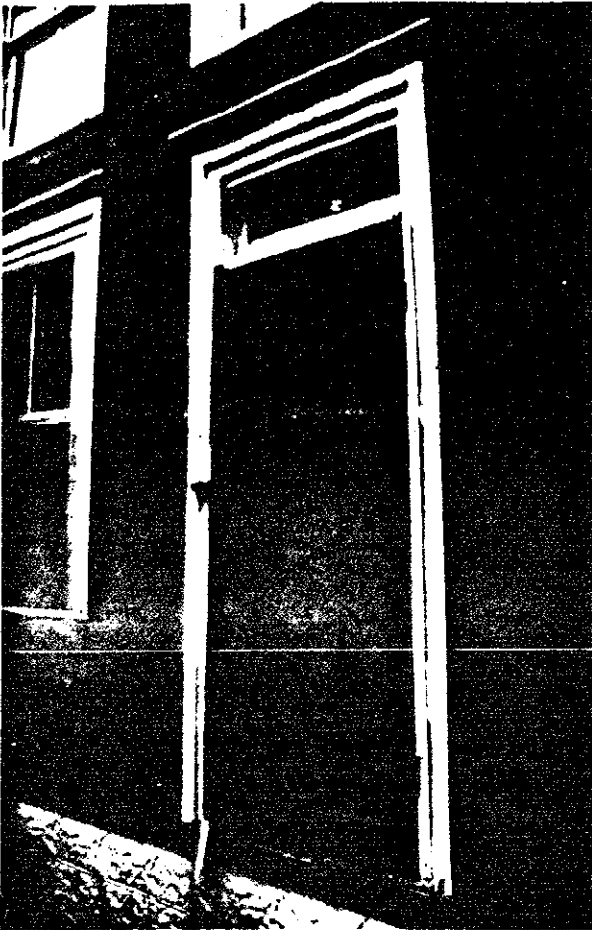
Close-up of door in the
southwest elevation of the
White Hotel in
1981.

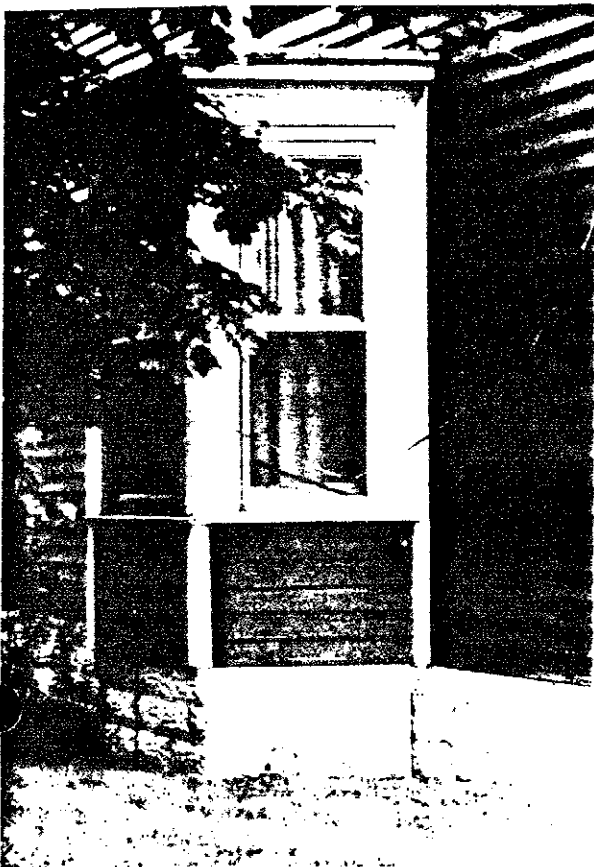
Close-up of bay window in
the southwest elevation of the
White Hotel
in 1981
Note the rock-faced sheet metal
skirting.

Foundation: The foundation of the structure appears to be composed of sandstone piers. However, the foundation is completely covered with a rusticated stone-impressioned sheet metal skirt painted white which makes determination of the nature of the foundation impossible.

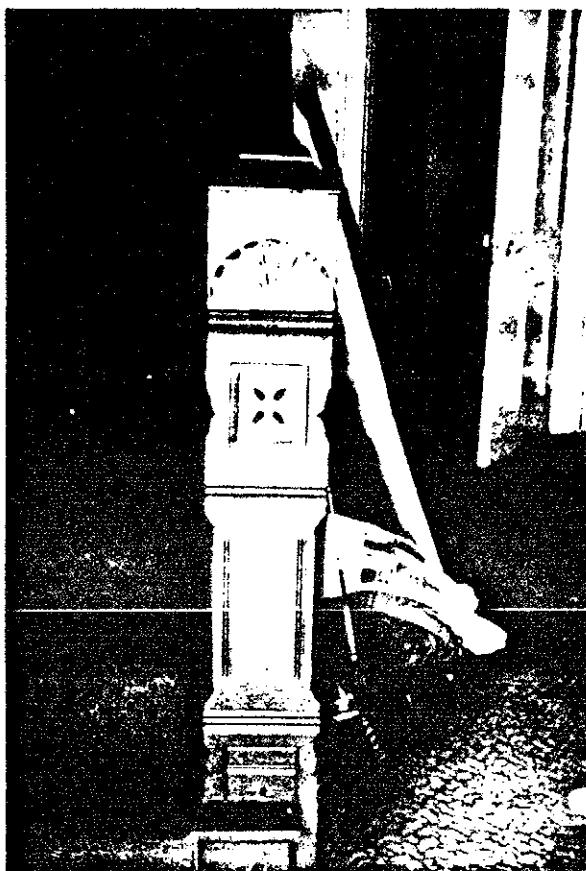
Close-up of stairway
newel post in Room 1 of the
White Hotel in
1981

The second floor is reached by ascending 12 steps and a riser to a landing (34" wide x 34 1/2" deep). A 90° turn to the right leads to an additional step plus a riser to the upstairs hallway. The first 12 steps are 36 1/8" wide x 9 1/2" tread x 7" rise; they have a 3/4" nose. The last step (i.e., at the head of the steps) is somewhat narrower (33 1/2" wide) than other steps in the run. There are square newel posts at the foot and head of the stairway .

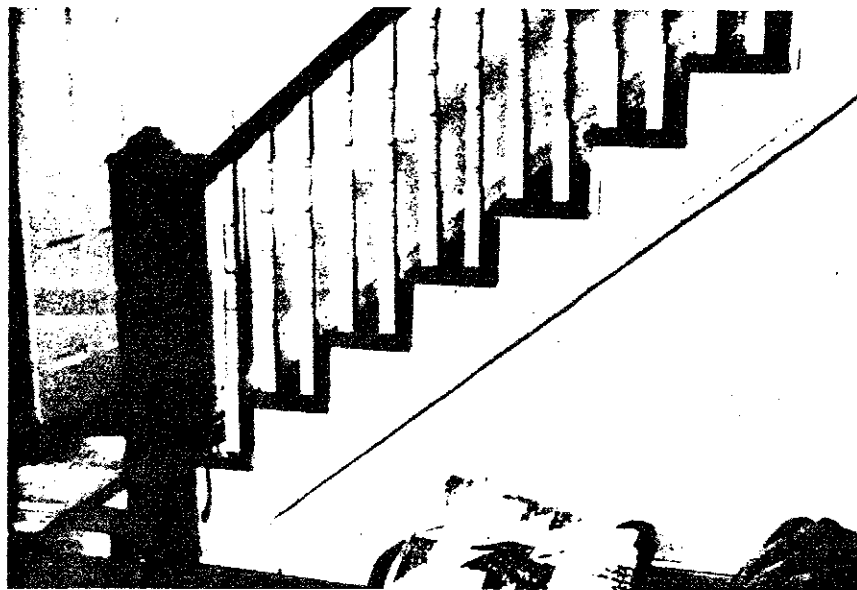
Close-up of stairway from first to second floor in the
White Hotel in 1981. Note the balusters and newel post at left

The railing is beaded, and the balusters are spindle-like .

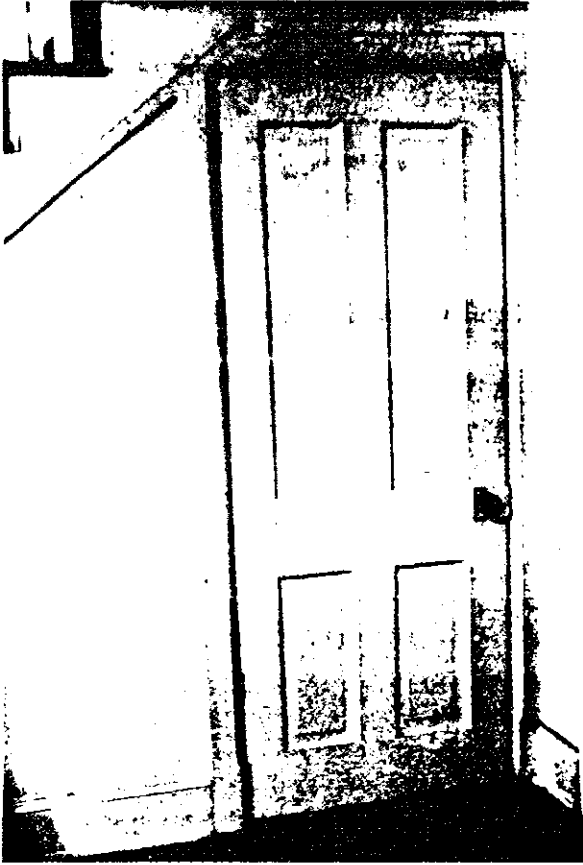
Close-up of Room 1 to
closet door in the White Hotel
in 1981. Note
the surround trim and rim lock

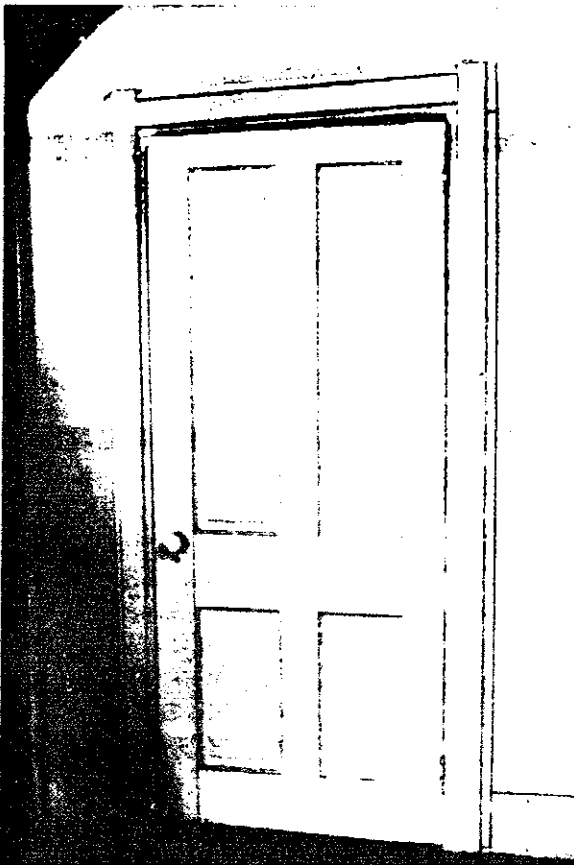
Close-up of Room 1 to
Room 7 door from Room 1 in the
White Hotel
ling in 1981. Note the surround trim

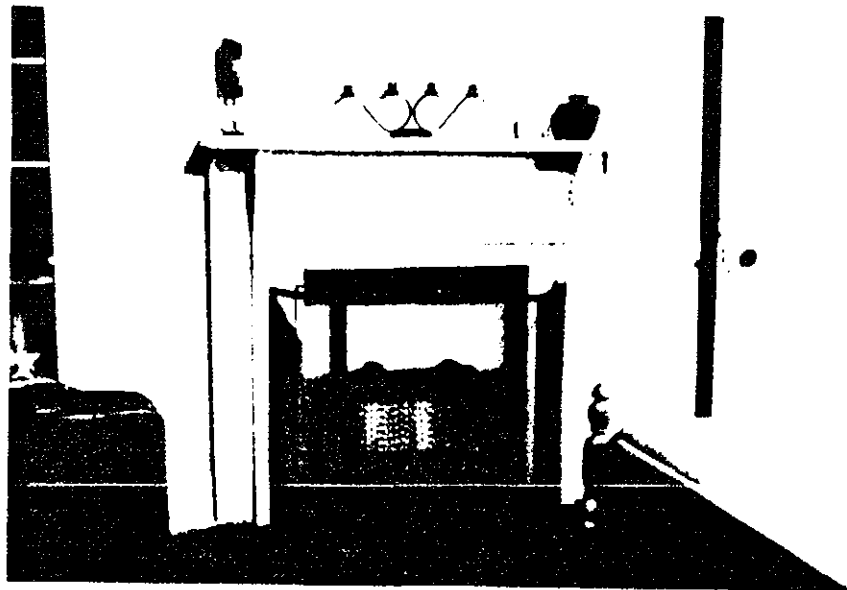
Close-up of fireplace and mantle in the northeast wall of Room 1 of the
White Hotel in 1981.

Fireplace: brick; 2'9" wide x 3' high x 11 1/2" deep firebox; 47" wide hearth of 1" square ceramic tile; wooden mantle .

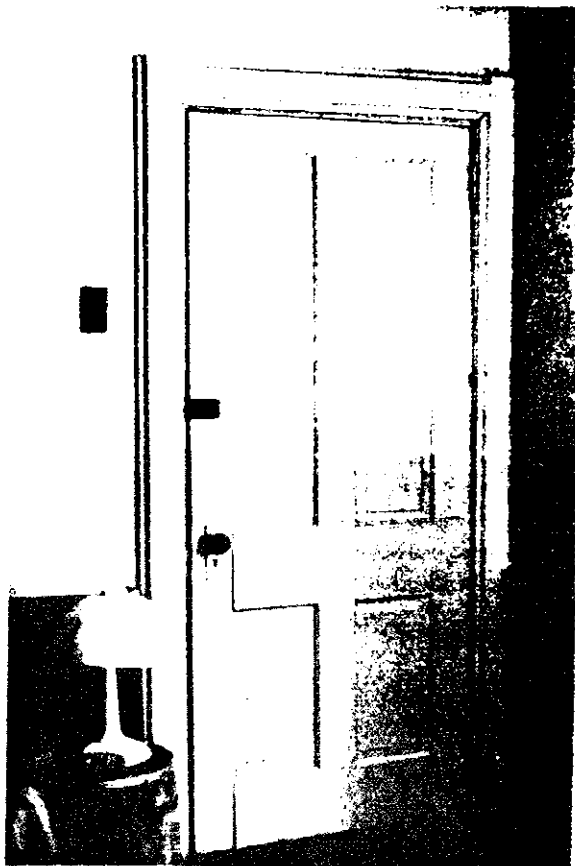
Close-up of Room 1 to
Room 2 door from Room 2 in the
White Hotel
in 1981

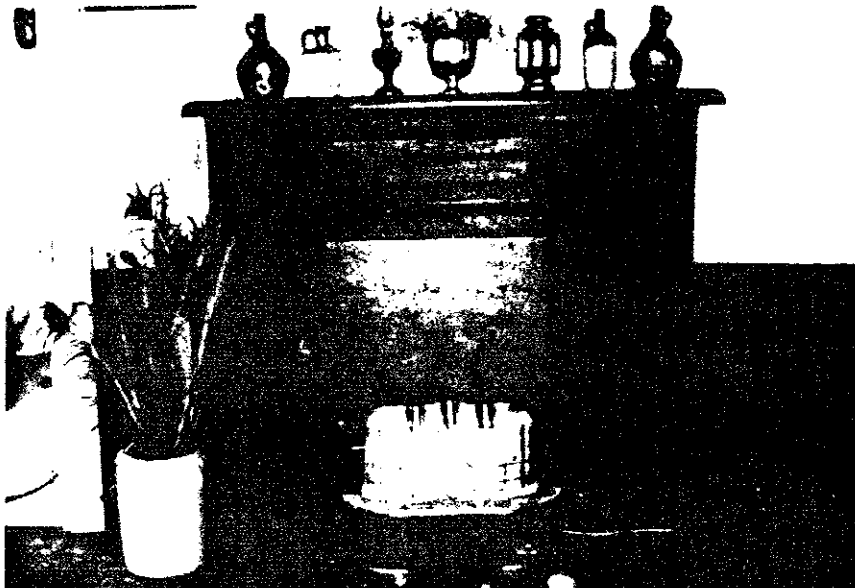
Close-up of fireplace and mantle in the northwest wall of Room 2 in the
White Hotel in 1981. Note the gas heater. The doorway to
Room 3 can be seen at left

Heating: gas heater attached to fireplace.

Fireplace: brick; 4' hearth of undetermined material; firebox depth, 1'9"; firebox closed with brick; wooden mantle .

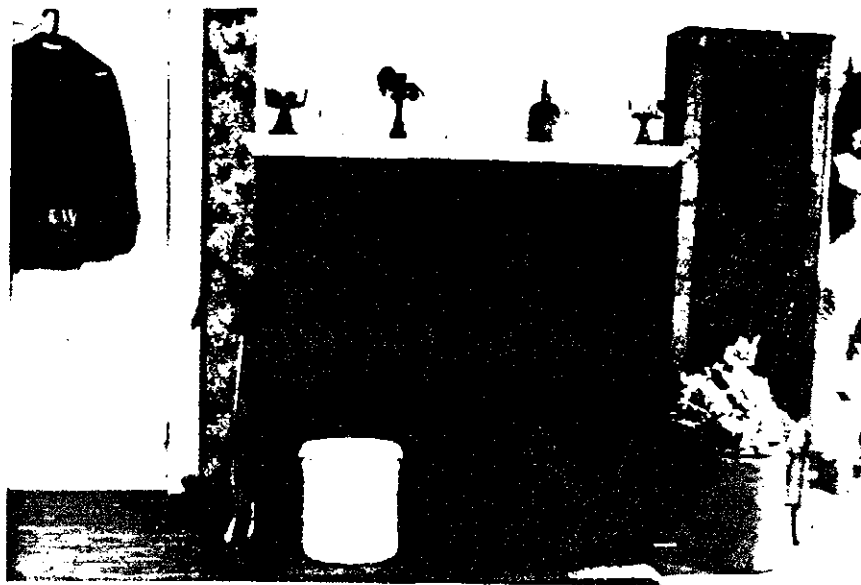
Close-up of fireplace and brick mantle in southeast wall of Room 3 of the
White Hotel in 1981. Note Room 3 to closet door at left.

Fireplace: coal burning grate; hearth measures 1'8 1/2" x 4'; modern brick mantle .

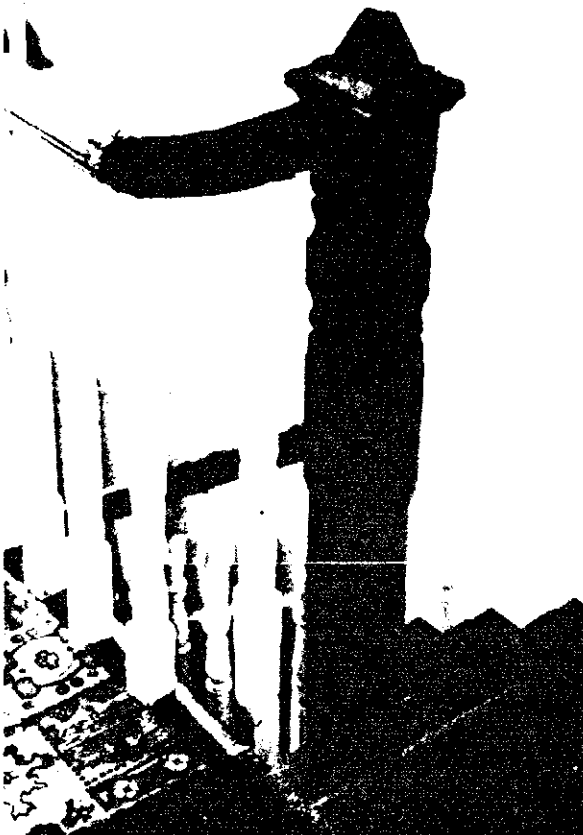
Close-up of newel post,
railing and balusters at head of Room
1 to Room 9 stairway in the
White Hotel in
1981

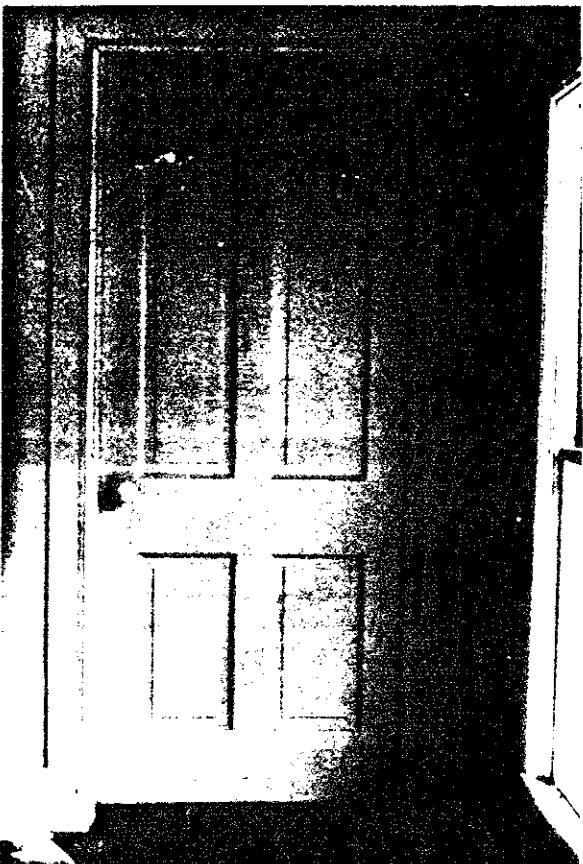
Close-up of Room 8 to
Room 9 door from Room 9

Room 8 to Room 9	2'7 1/2" x 6'7 1/4"	4 panel	3" ornate cast pin butt	4 1/8" x 3 3/8" rim lock; porcelain knobs	4 3/4" mold	4 3/4" mold	yes

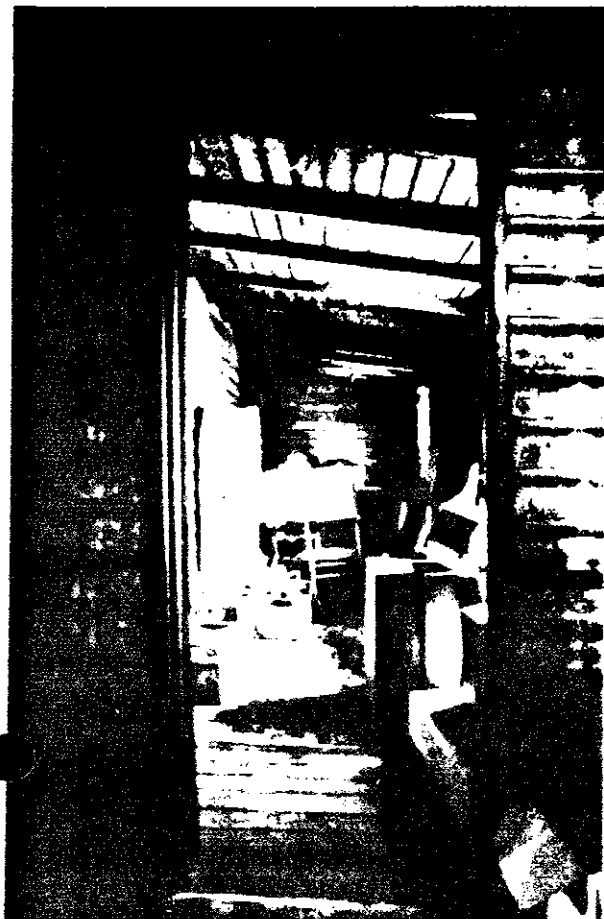
View through Room 13 to
Room 14 doorway from Room 13 in the
White Hotel

Note the sloping exposed
rafters in the ceiling.

Although it is now largely obscured, second floor Rooms 13 and 14 were originally an open porch and constituted perhaps the only accesses to Rooms 11 and 12; the area was later enclosed to form two rooms and in all likelihood doorways from Room 11 to Room 12 and from Room 14 to Room 11 were installed at that time; when the porch was converted into Rooms 13 and 14, the windows on the northeast side of Rooms 11 and 12 also were closed off.

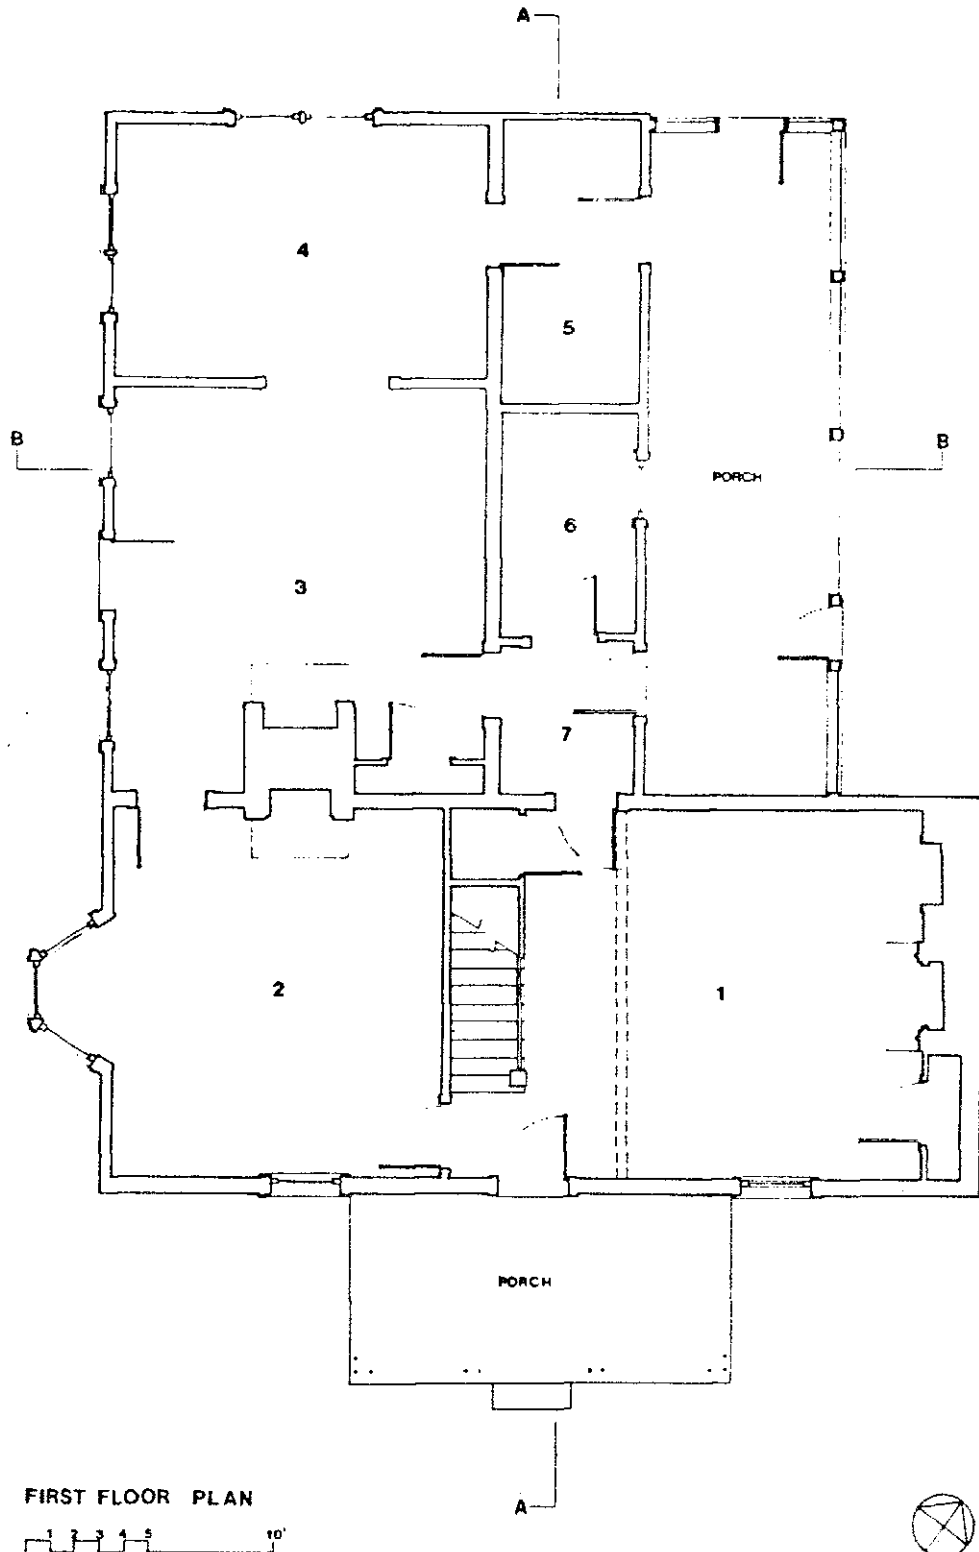
First floor plan of the White Hotel

Interior Description: Room 1 (room numbers are keyed to floor plans on pages 36-37)

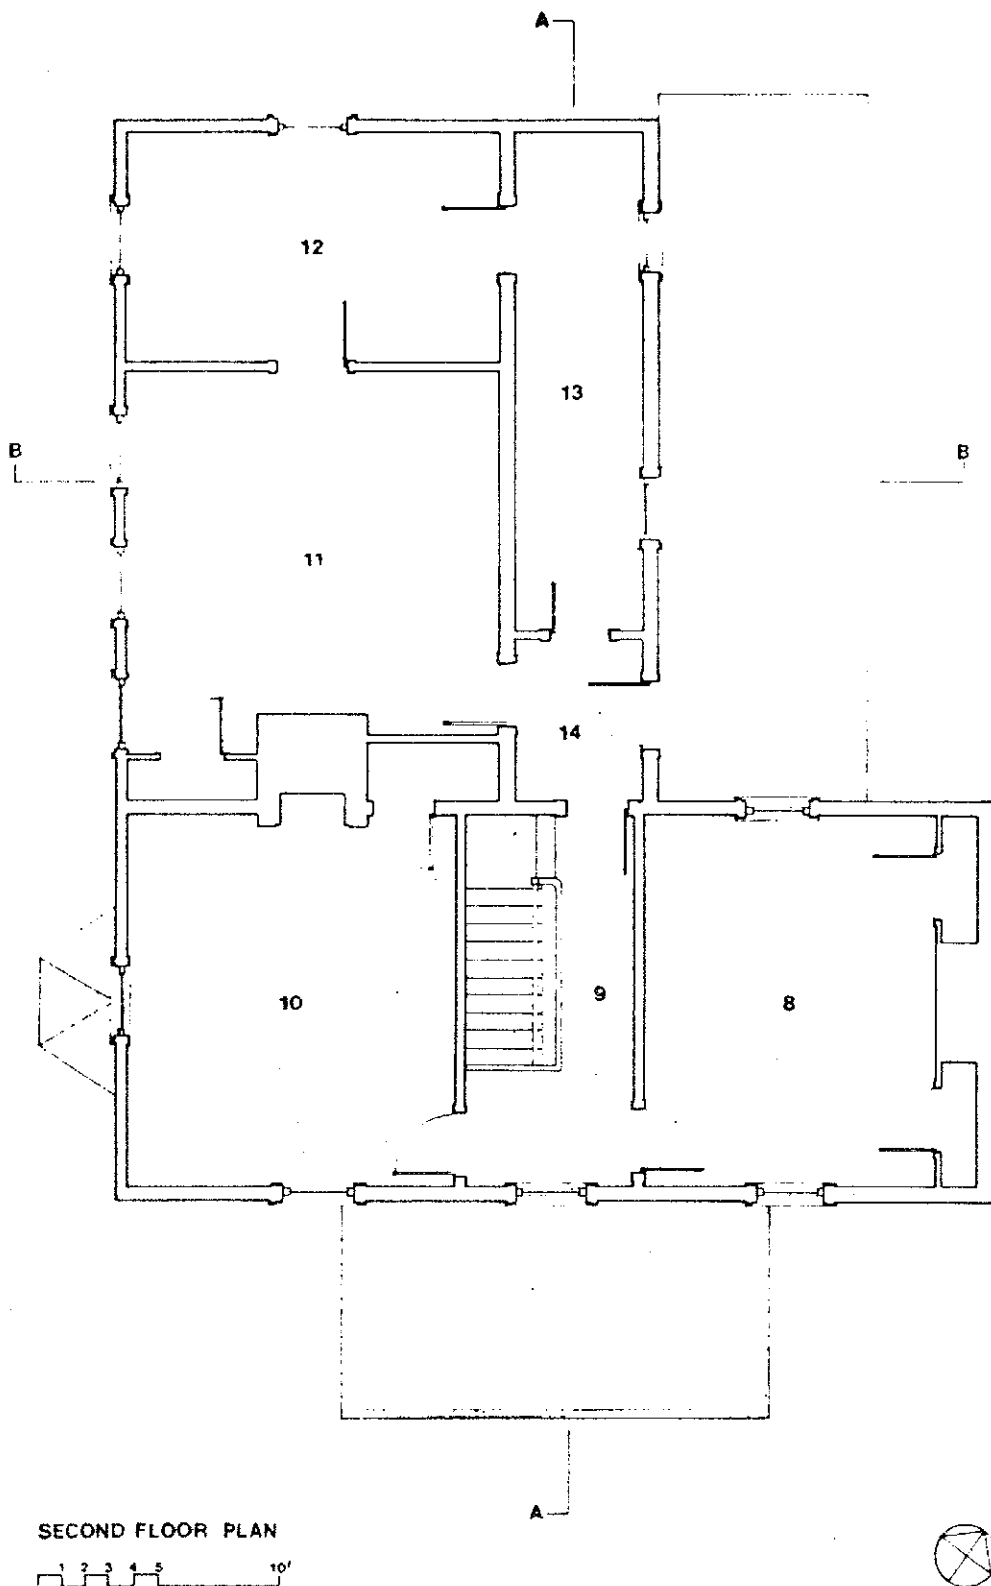
Second floor plan of the White Hotel

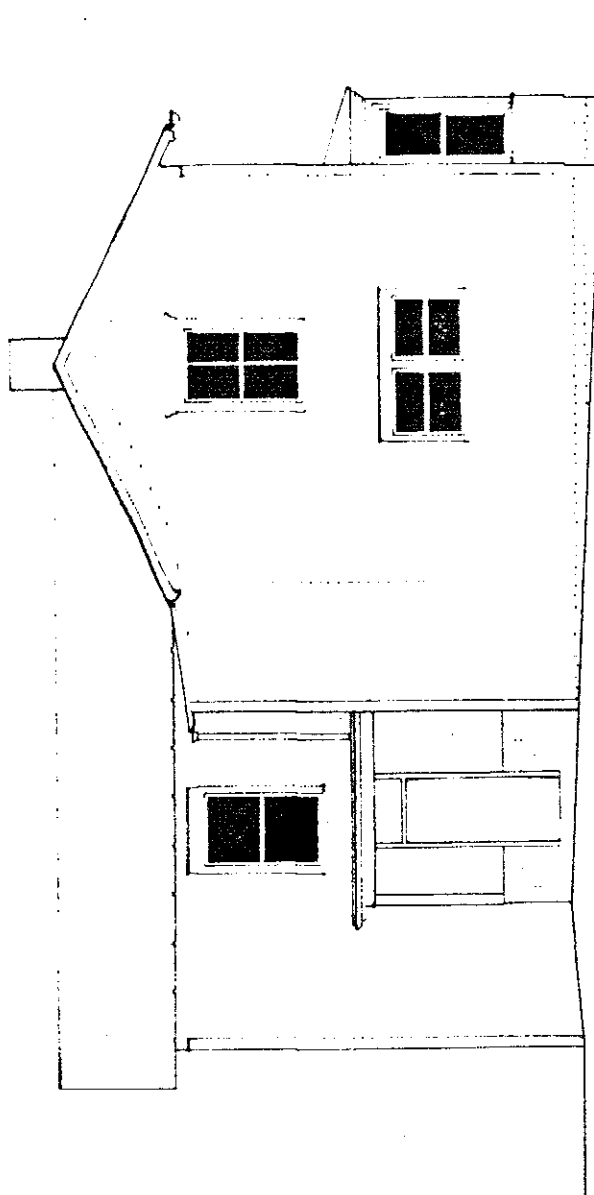
NORTHWEST ELEVATION

Northwest elevation of the White Hotel

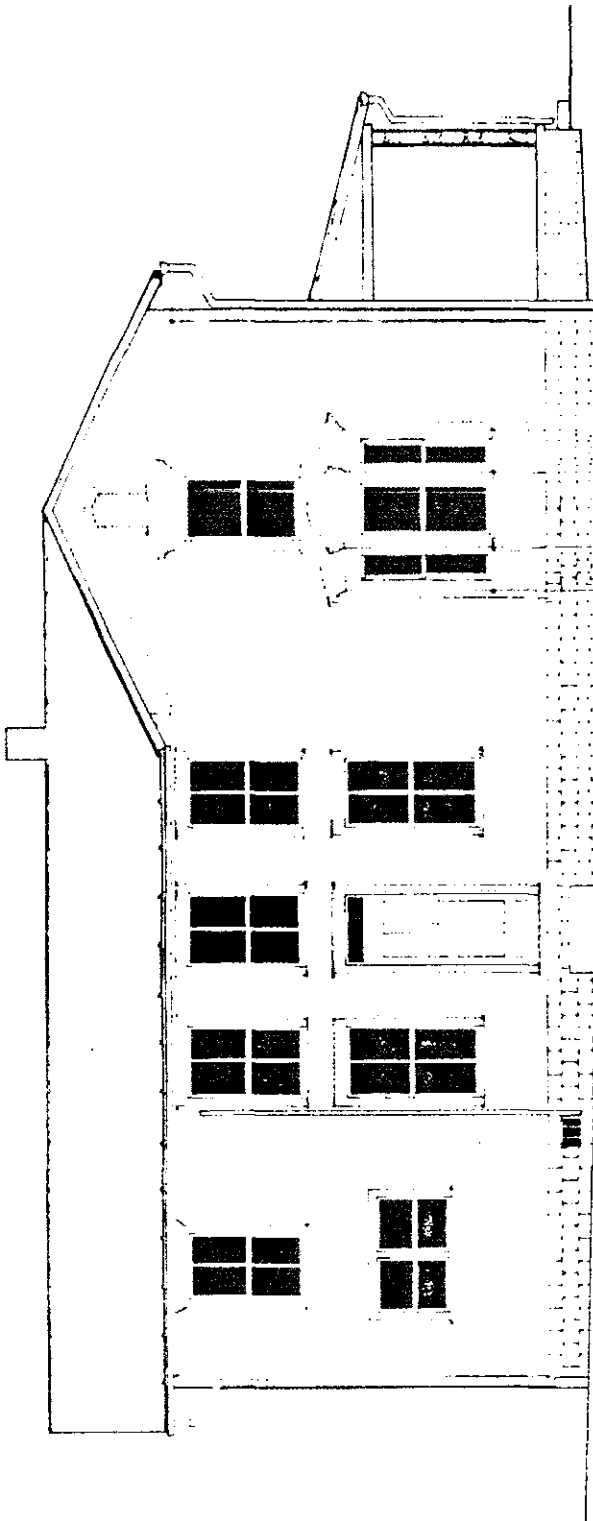
SOUTHWEST ELEVATION

Southwest elevation of the White Hotel

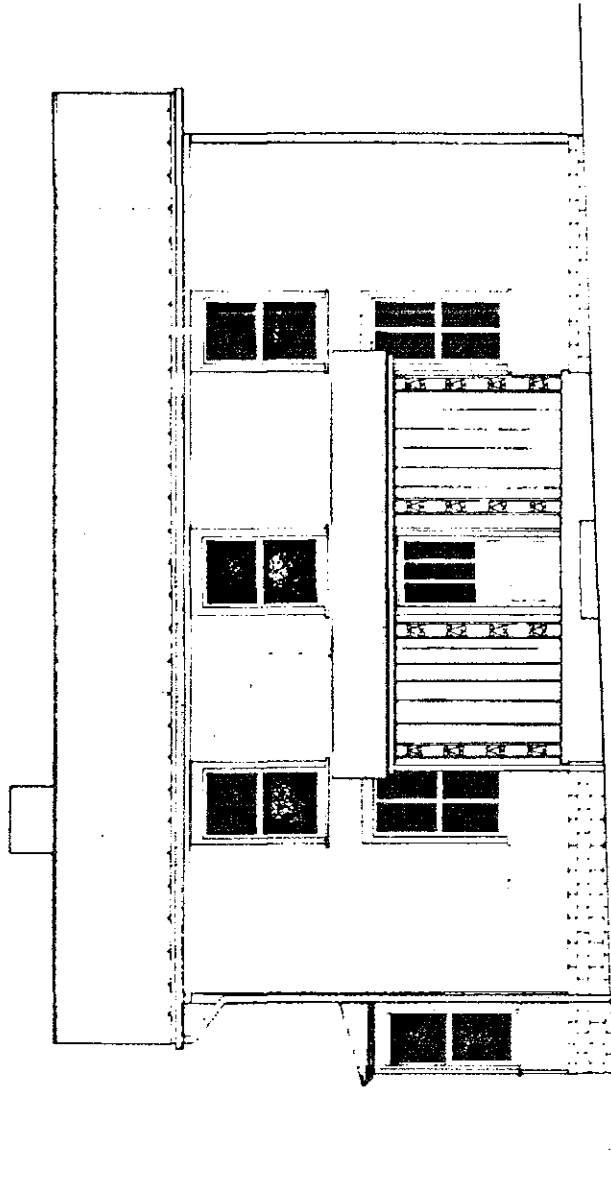
SOUTHEAST ELEVATION
10'

Southeast elevation of the White Hotel

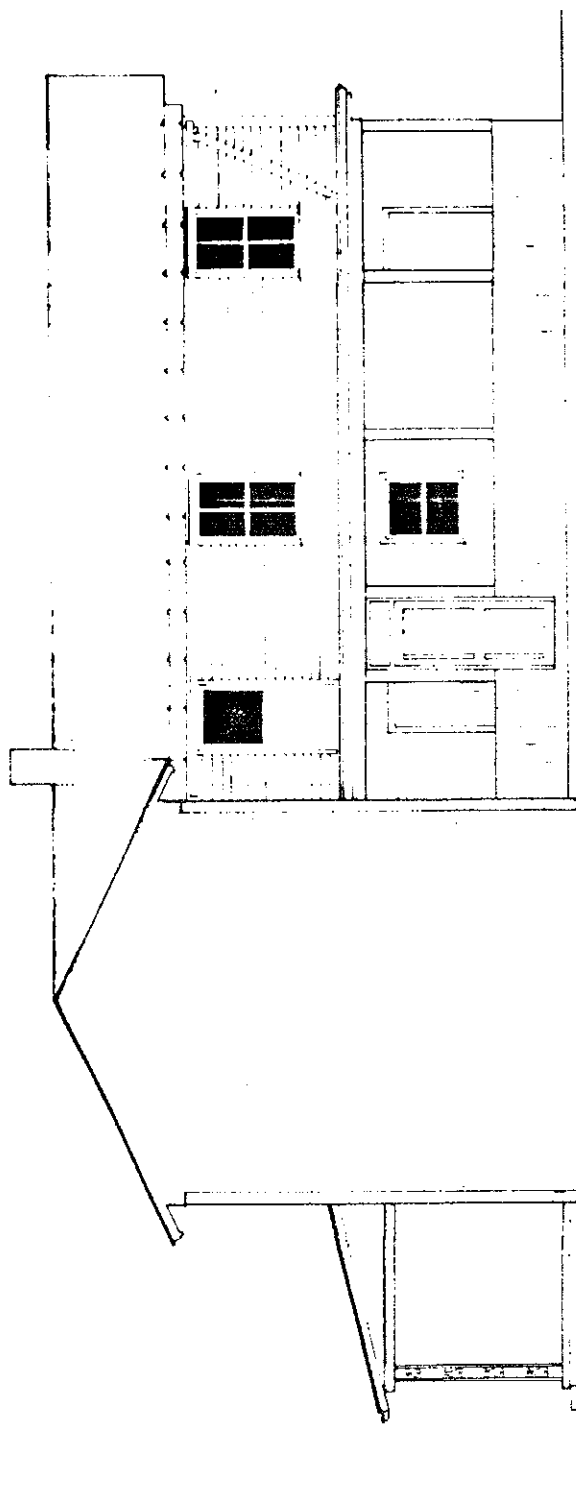
NORTHEAST ELEVATION
1" = 10'

Northeast elevation of the White Hotel

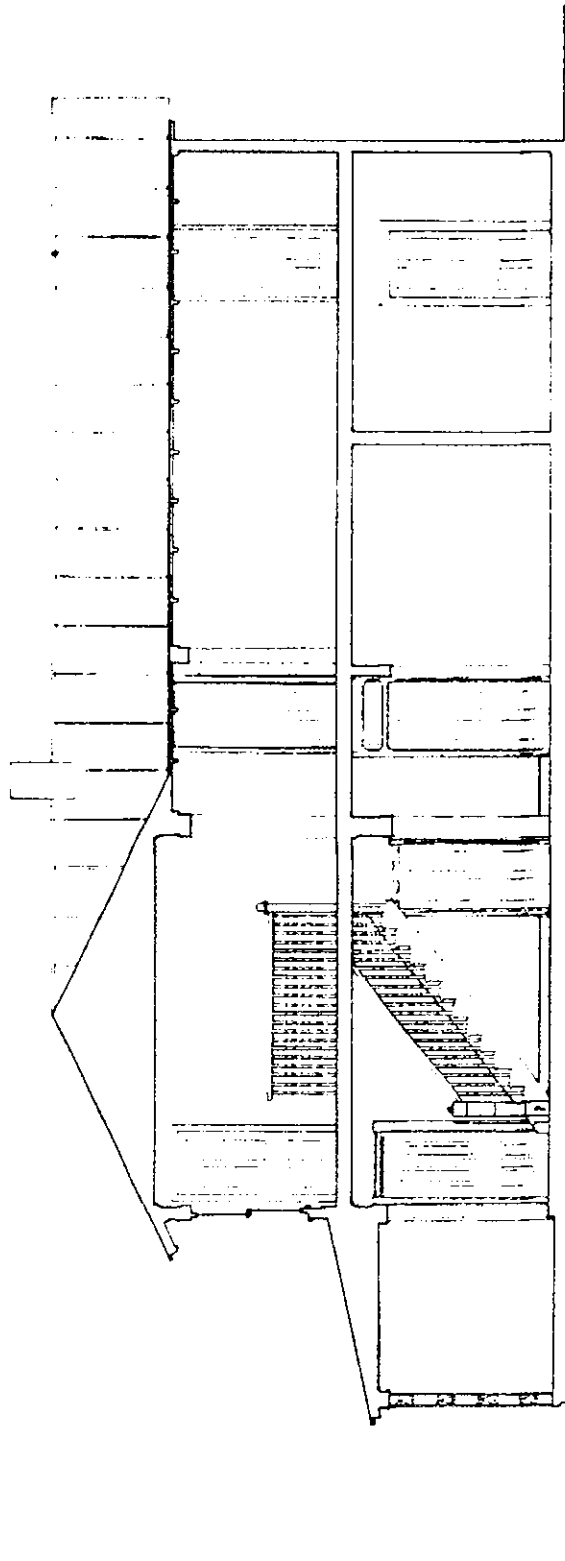
SECTION A-A

Longitudinal section (A-A) through the White Hotel

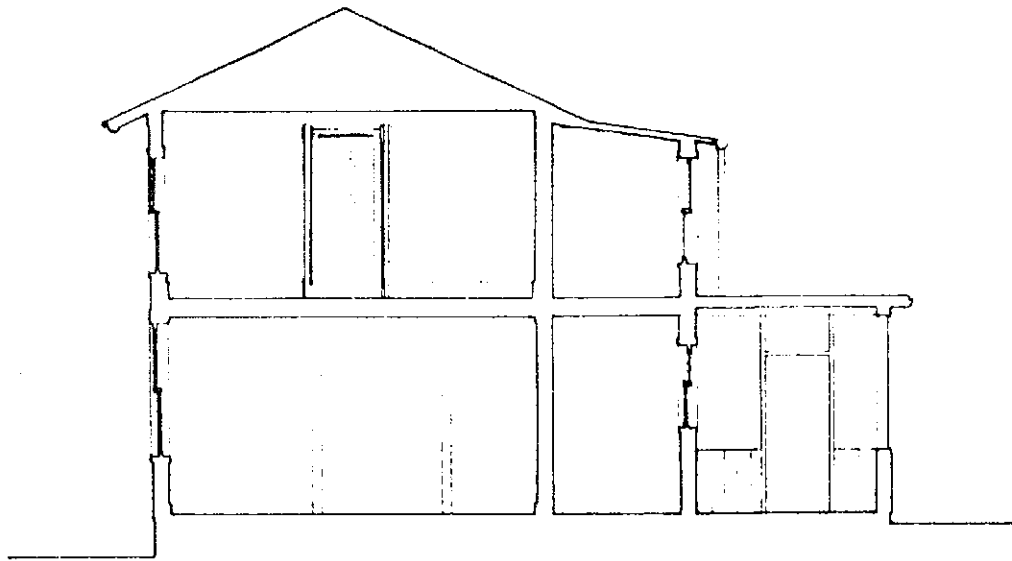
SECTION B-B

Transverse section (B-B) through the White Hotel

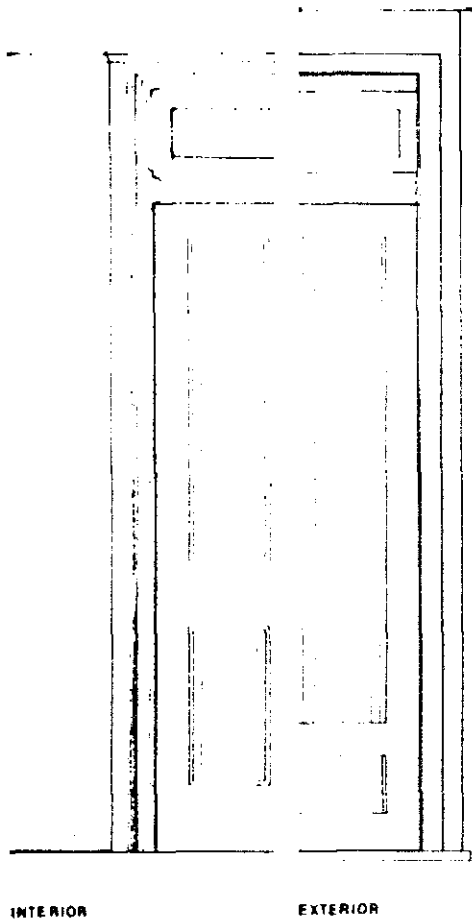
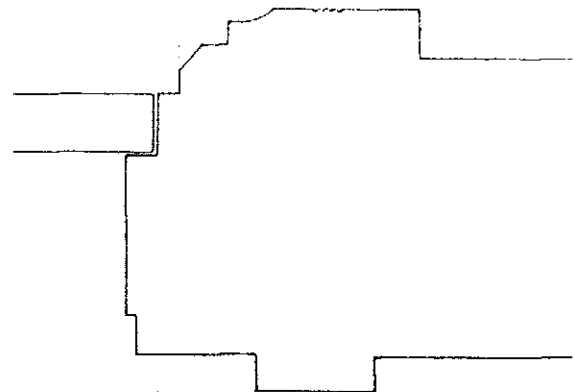
TYPICAL TRANSOM DOOR DETAIL

TYPICAL DOOR MOLDING

Typical door details in the White Hotel

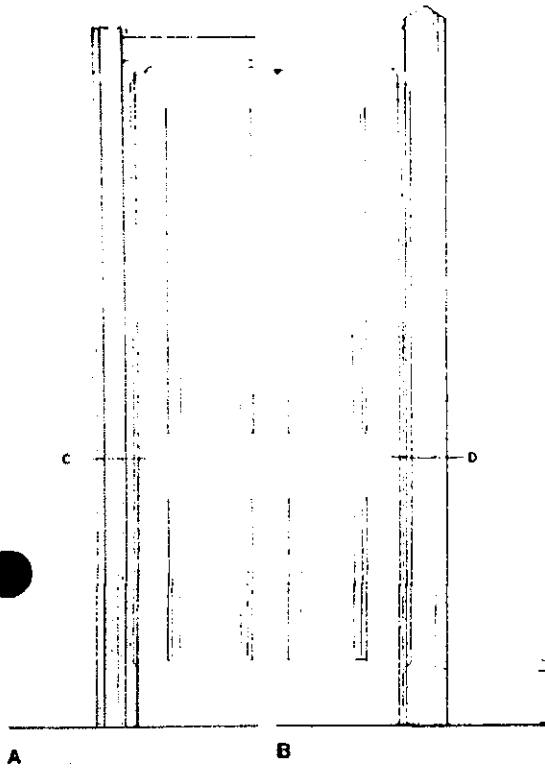
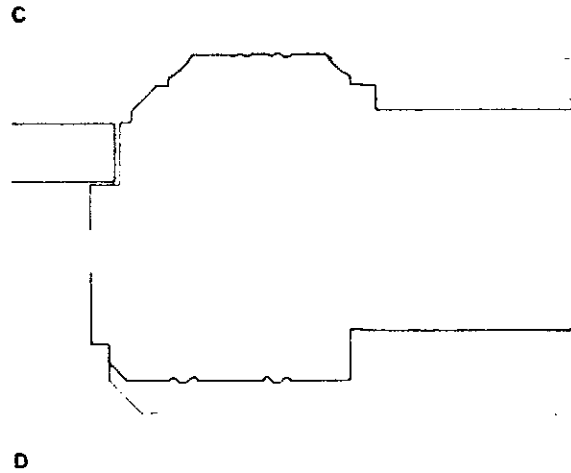
TYPICAL DOOR DETAILS

TYPICAL DOOR MOLDINGS

Typical door details in the White Hotel

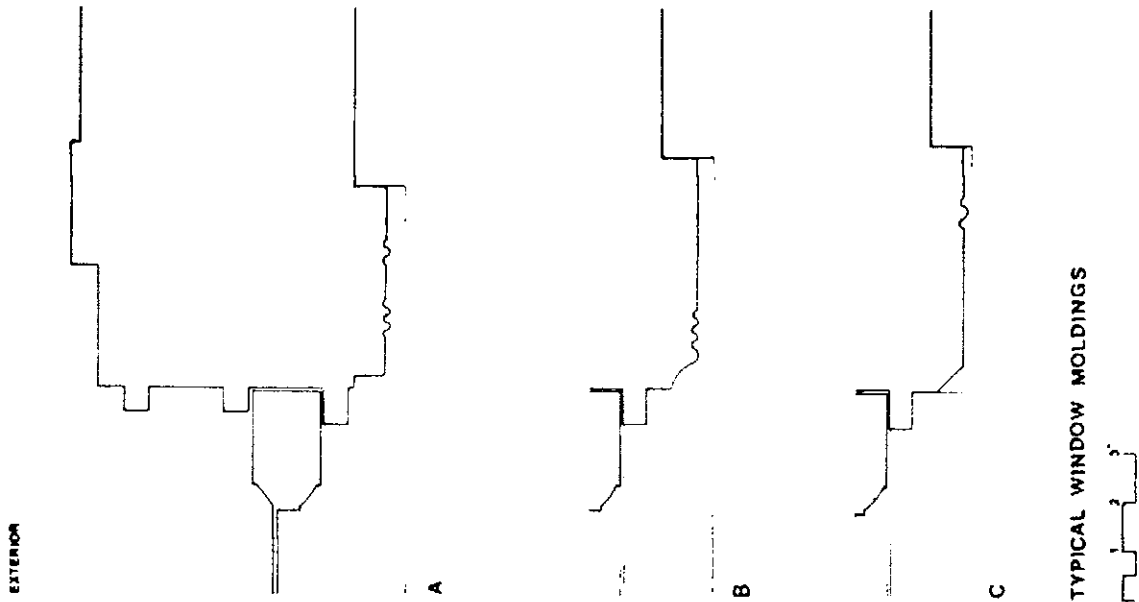
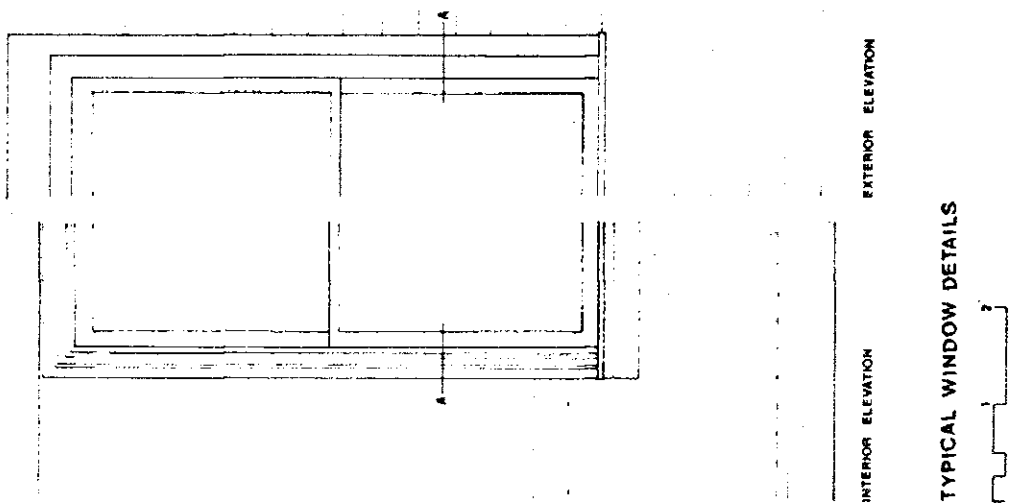
Typical window details in the White Hotel
